Portage Creek Sediment Remediation Project Kalamazoo, Michigan

Pre-Sediment Removal Structure Feature Assessment Removal Areas SA5-Axtell, SA5-D and SA5-C

F&V Project Number: 809930
May, 2012

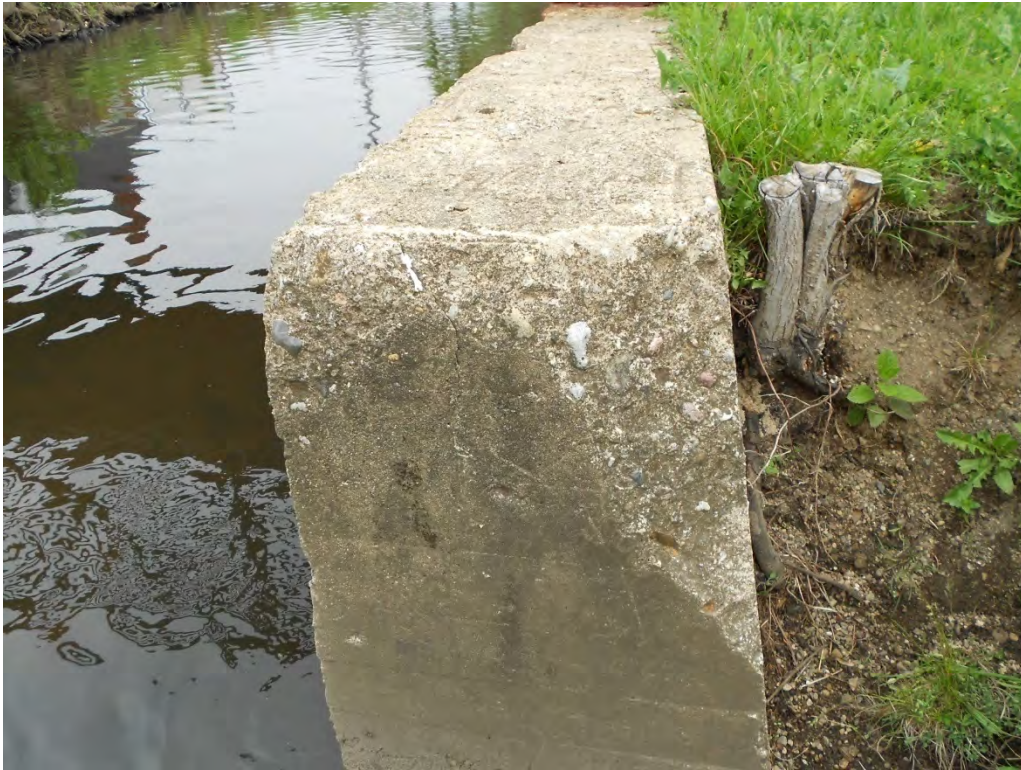
- Moderate bank erosion was noted around the southeast abutment. Roots from large stumps are holding the west banks.
- The top corners of the abutments are spalled throughout.
- The channel bottom is approximately 5' below the bottom chord of the truss. Logs and trash were noted in the northeast channel.
- The truss is weathering steel and has developed its patina, but minor pitting was noted.
- The timber decking has moderate weathering and splitting of planks throughout.

Spalling on the southeast abutment

- Construction records are not available for this structure, however it is suspected that the abutments are supported on spread footings several feet below the current channel bottom. We understand that the steel truss is to be temporarily removed to accommodate sediment removal. In this case, a cofferdam is recommended around each abutment to protect them from undermining. Because of the suspected depth of footing, it may be possible to begin sediment removal without cofferdams and install them only if the sediment removal is required below the bottom of footing elevation.
- If the truss is not removed, a simple isolation cofferdam across the channel is recommended upstream and downstream a minimum of 2' clear of the abutments.

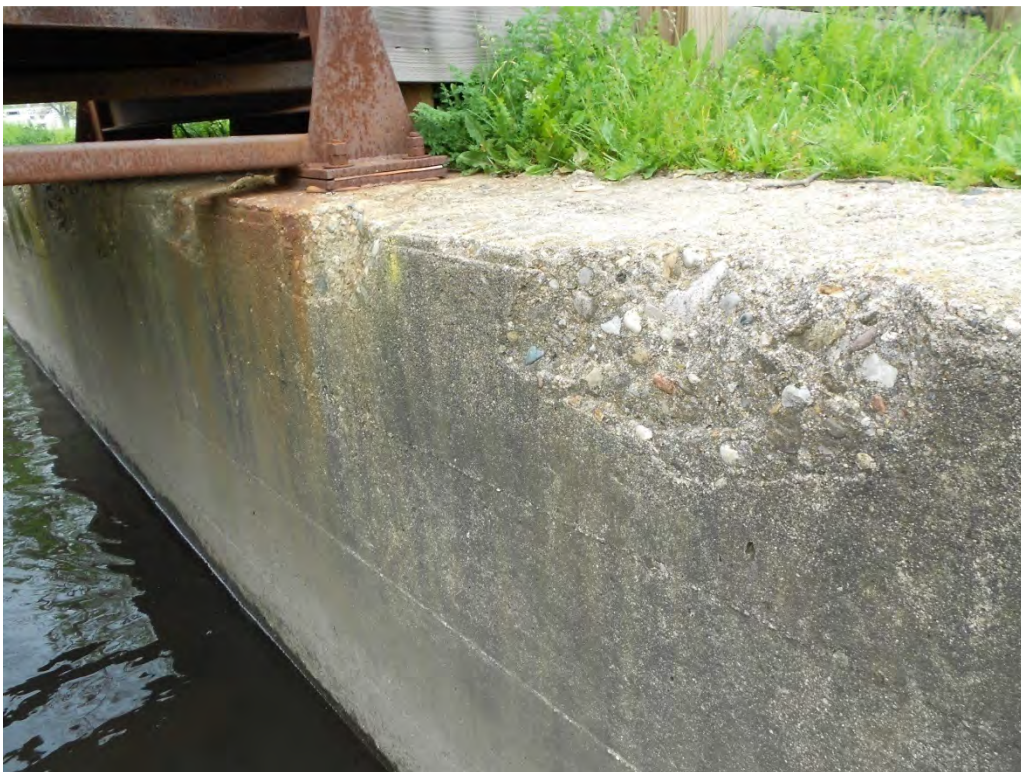
Spalling on the southeast abutment

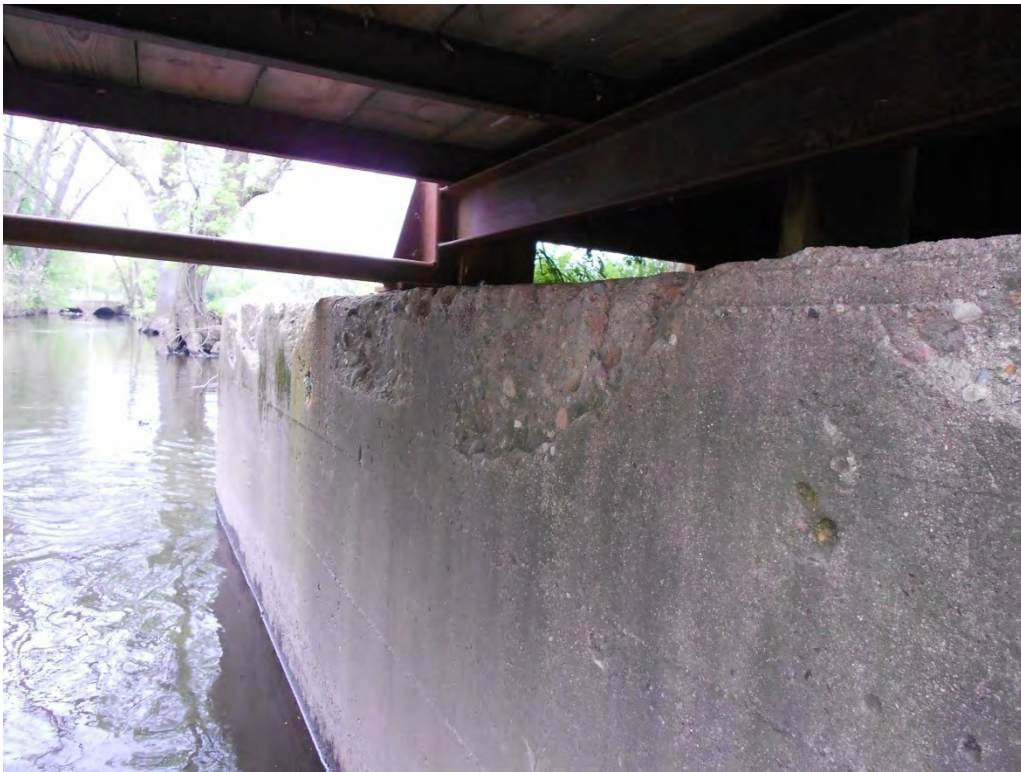
Spalling on the east abutment

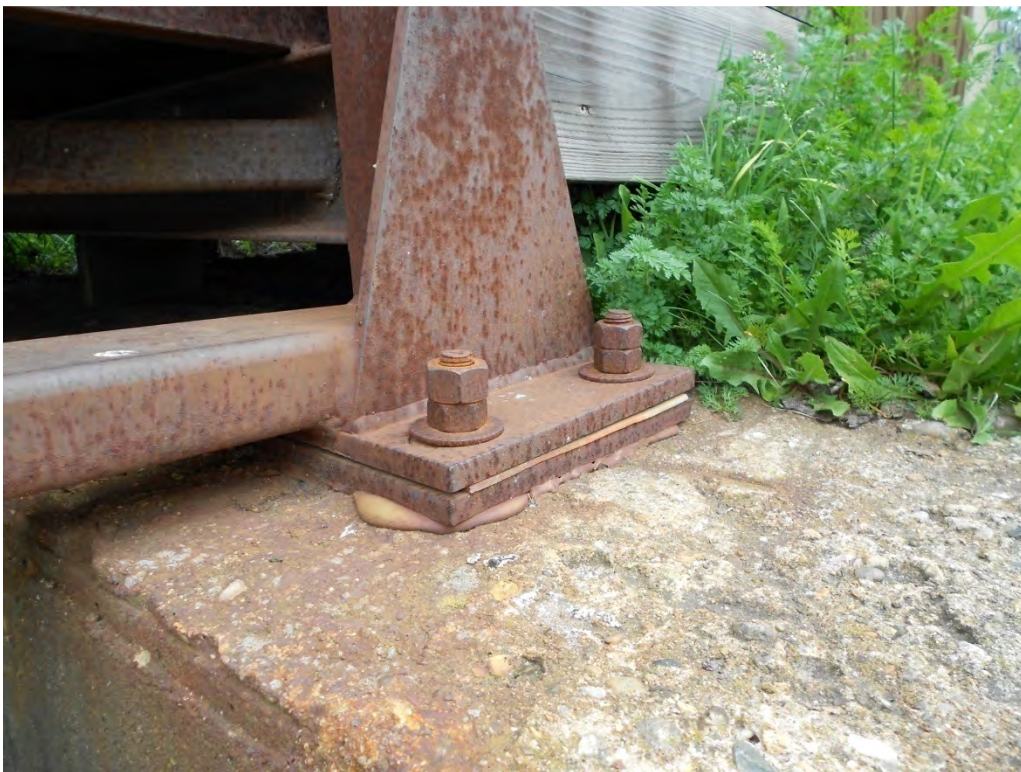
Minor pitting on steel at the southeast bearing

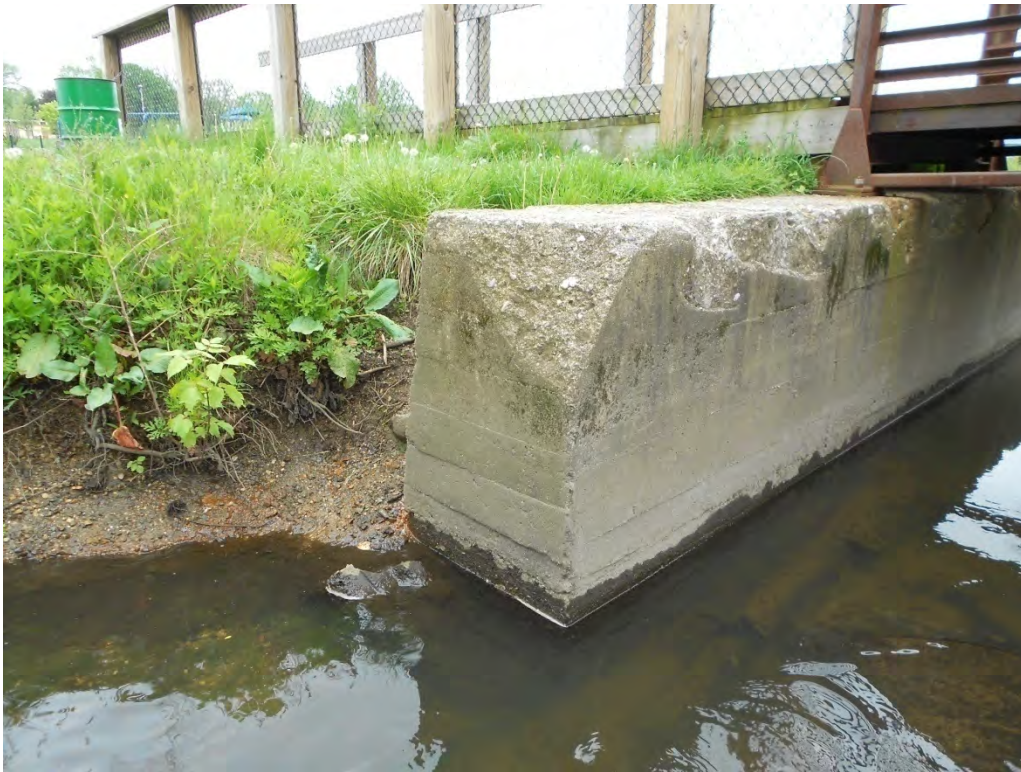
Abutment spalling in the northeast

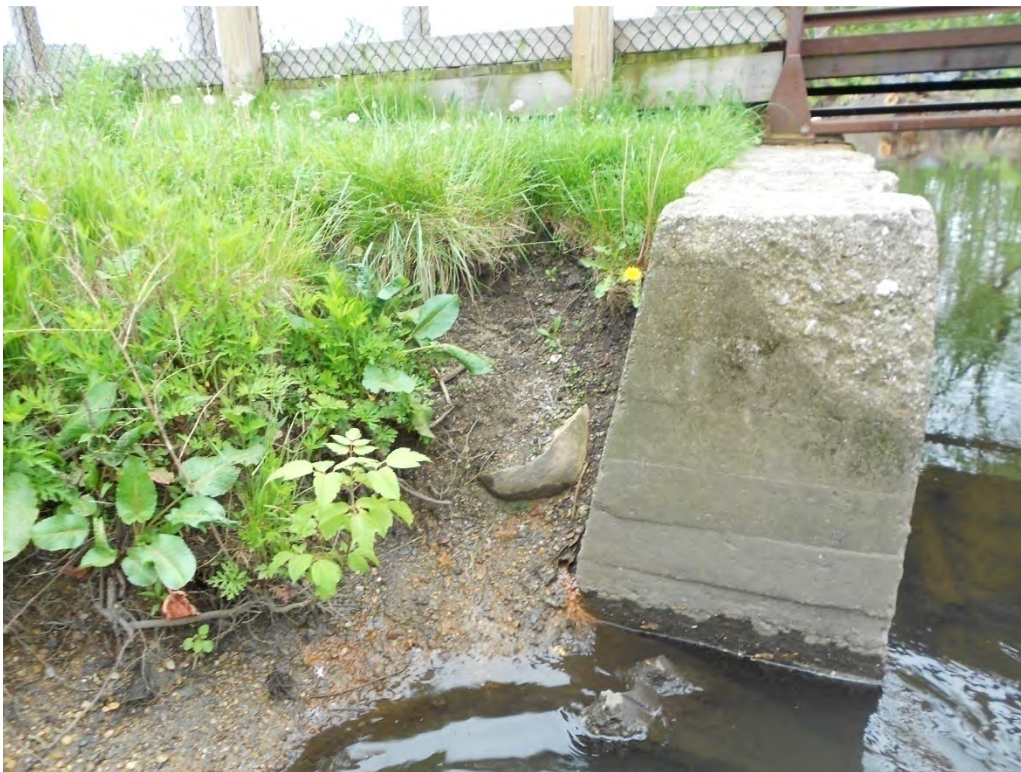
Bank erosion around northeast abutment

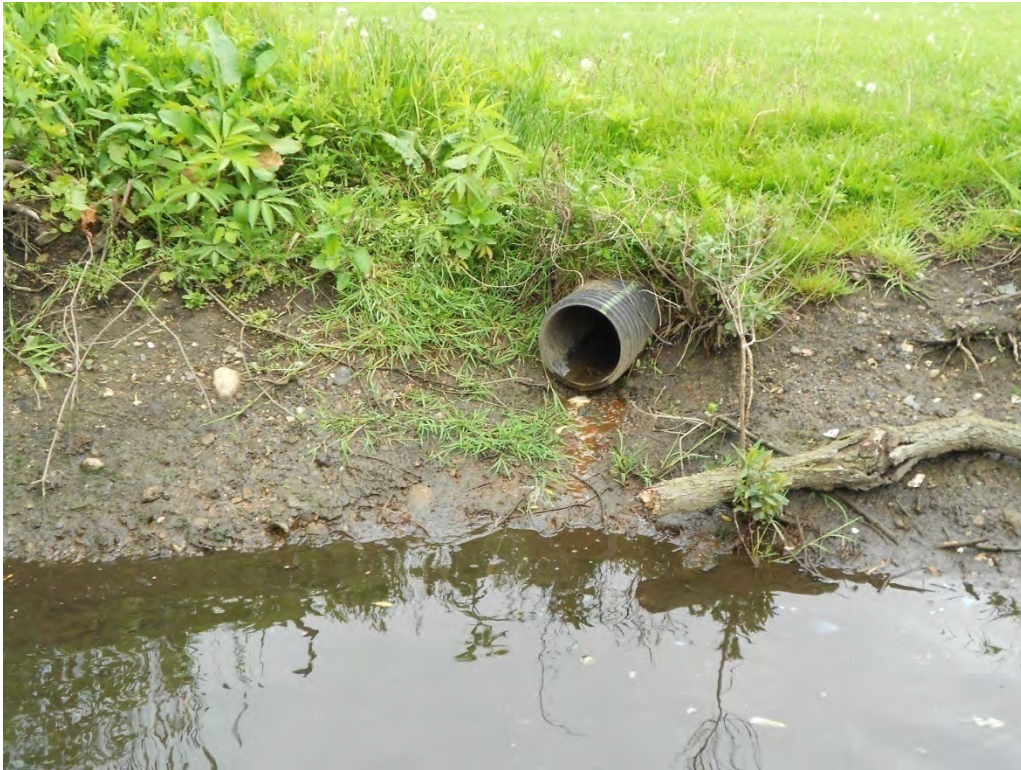
- Moderate bank erosion has exposed ~12-18" of the pipe, however, the pipe is set back approximately 2' from the water's edge in an area where the bank is low.
- The pipe appears to be in good condition with no significant deterioration noted.
- The outlet is slightly undermined.

View of the outlet from the channel

- Because the structure is set back from the water's edge, further undermining is not a significant concern. However, undermining should be repaired if it does occur.
- At the time of evaluation, the outlet had a small flow of water and an isolation cofferdam is recommended for dewatering.

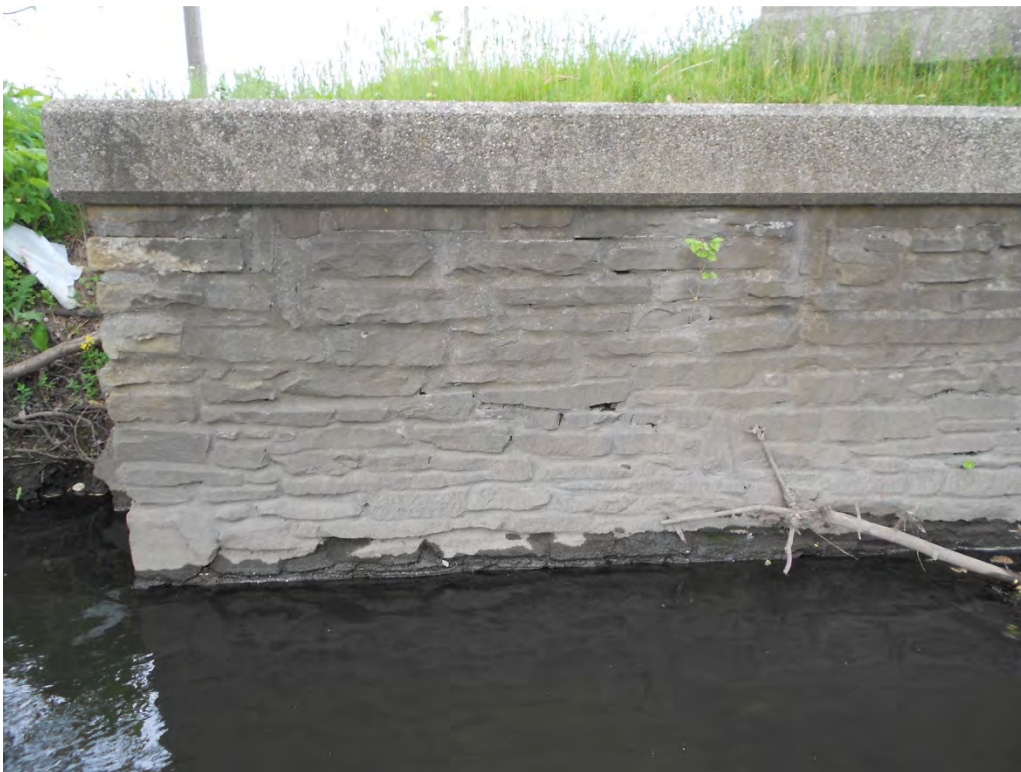
- Moderate erosion was noted behind the southwest wingwall with concrete rubble placed as riprap. Cracking and gaps were noted in the mortar joints.
- There is a significant amount of woody debris caught on the upstream face of the structure. The debris is reducing the flow in the west pipe, causing high velocities and deepened channel in the east pipe.

Cracking and gaps in mortar joints of southwest wingwall

- The wingwalls and headwalls are masonry-type construction with various degrees of cracking and are more susceptible to damage from vibration than concrete. Therefore it is recommended that the cofferdams at the Crosstown Parkway bridge be constructed of sand bag walls, placed with approximately 4' clearance from the walls.
- The unidentified steel cover in the northwest should be excavated and opened prior to cofferdam installation to check for a possible utility crossing.

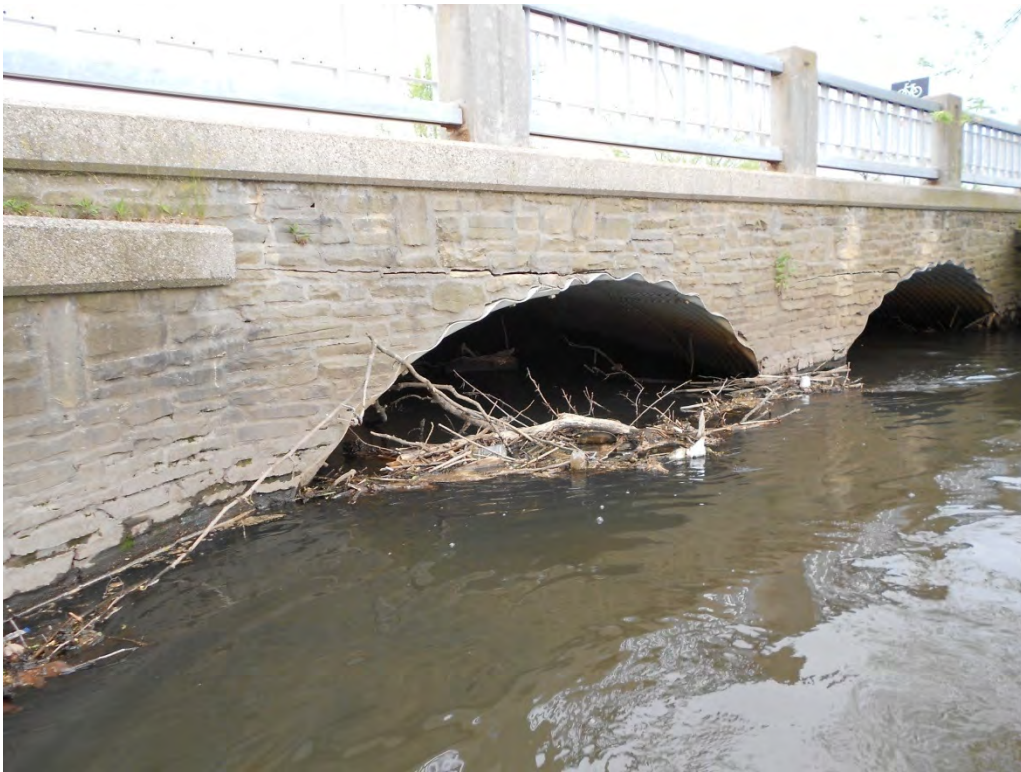
Woody debris caught on upstream face of structure

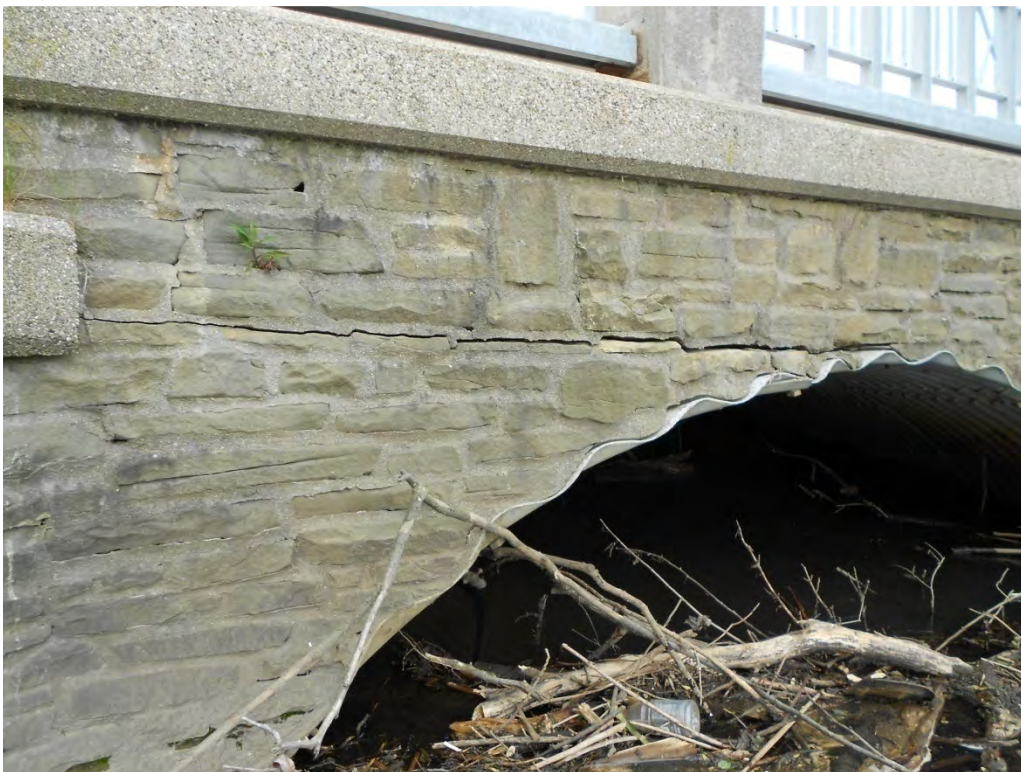
- There is severe horizontal cracking in the south headwall, approximately 1/2" wide from the high point of both culverts heading west. Scattered vertical cracking was noted as well.

Severe horizontal cracking in southwest headwall

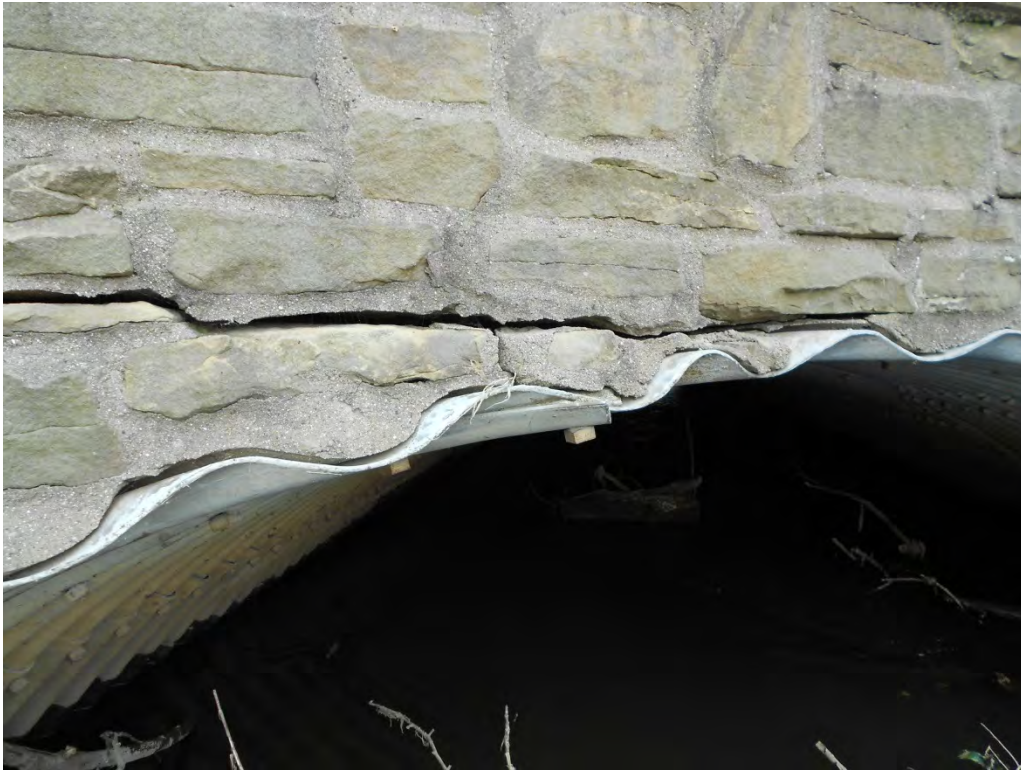
Close-up of cracking in southeast headwall

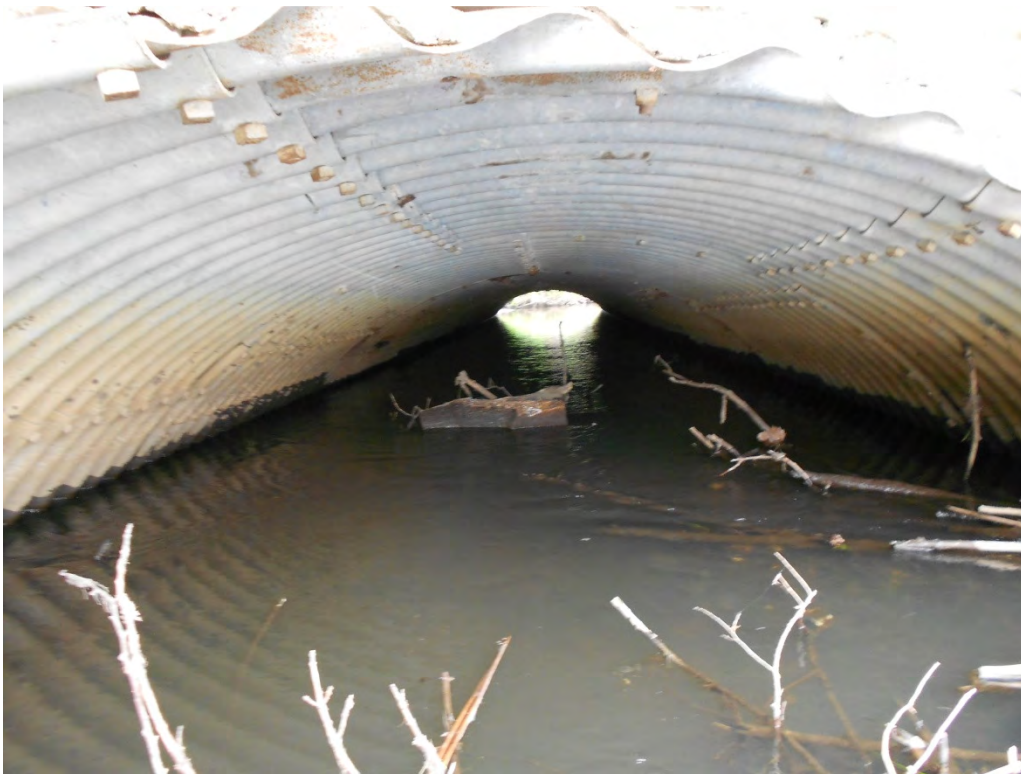
- Minor sagging was noted in the culvert pipes below the roadway. Minor corrosion was noted at the joints between plates, severe in spots.
- The surface is newer asphalt, concrete curb and gutter. There are newer concrete sidewalks between the curbs and headwalls.

Minor sagging of culvert under roadway

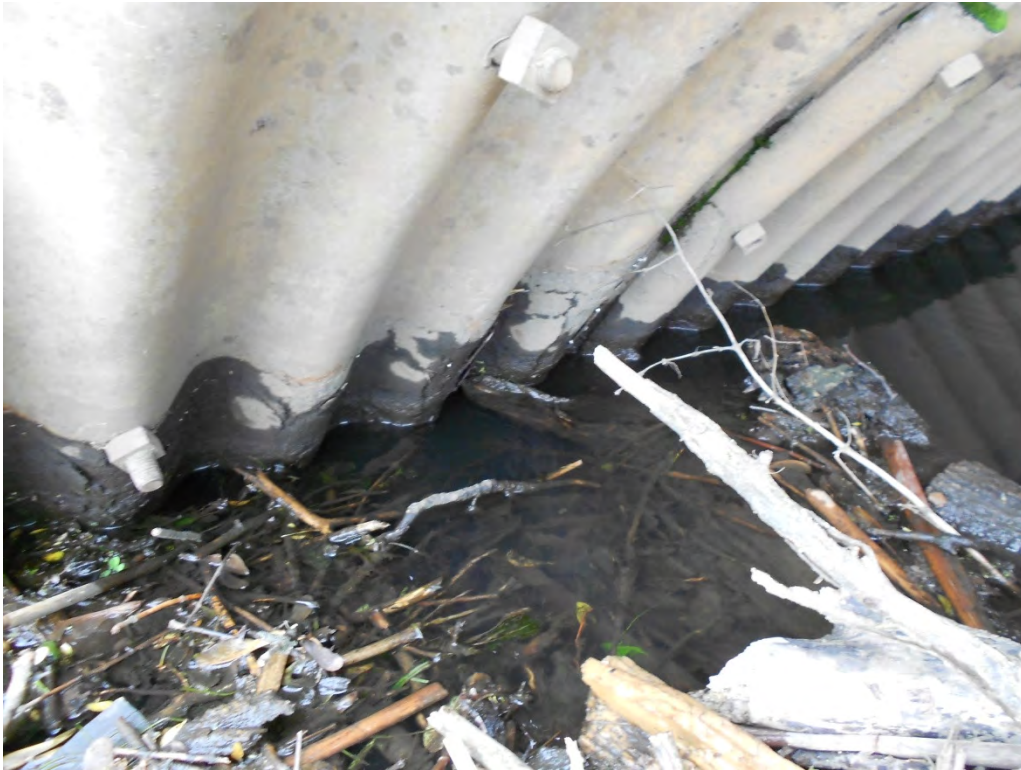
- Minor surface corrosion was noted on the culverts above the waterline and moderate to severe corrosion with scaling at the waterline.
- There is a large tree growing at the end of the southeast wingwall. The southeast wingwall has minor gaps and cracks in the mortar joints. There is a large sinkhole behind the wall filled with concrete rubble.

Corrosion and scaling of steel plate along waterline

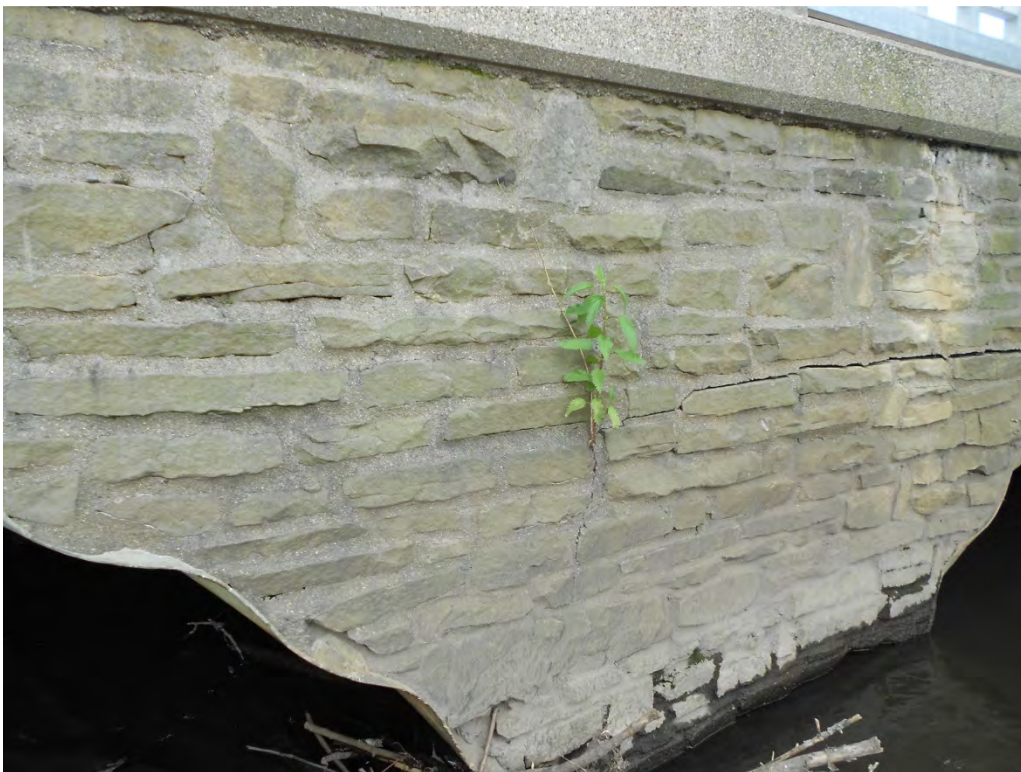
Vegetation growth through cracking in south headwall

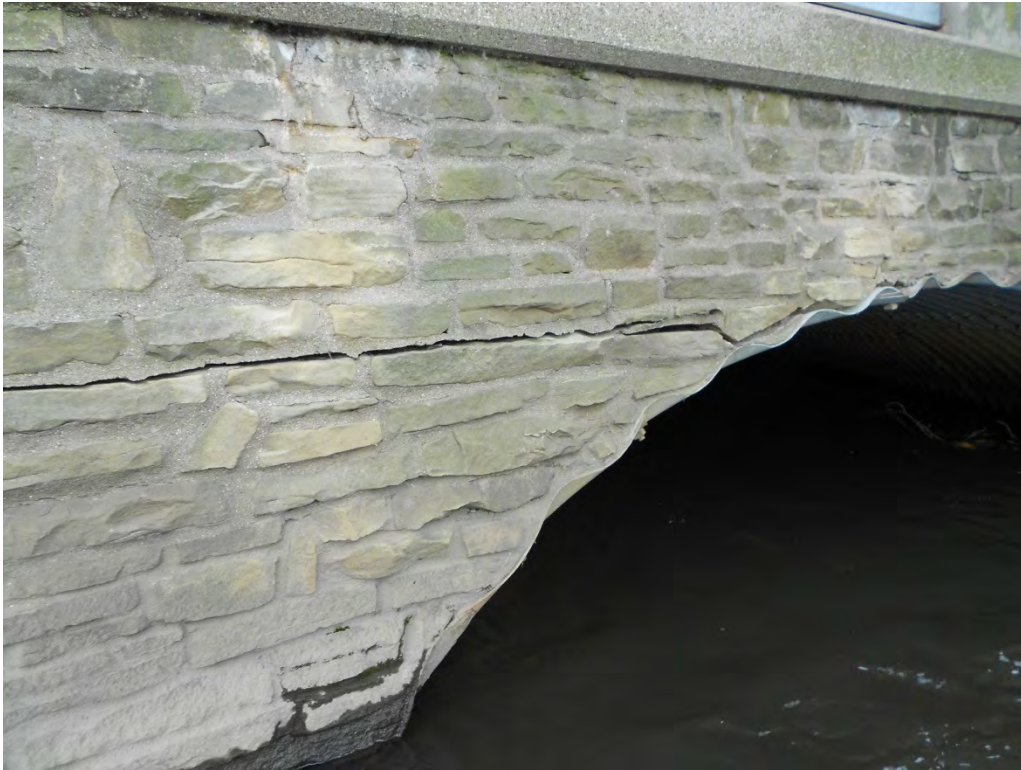
Horizontal cracking in southeast headwall

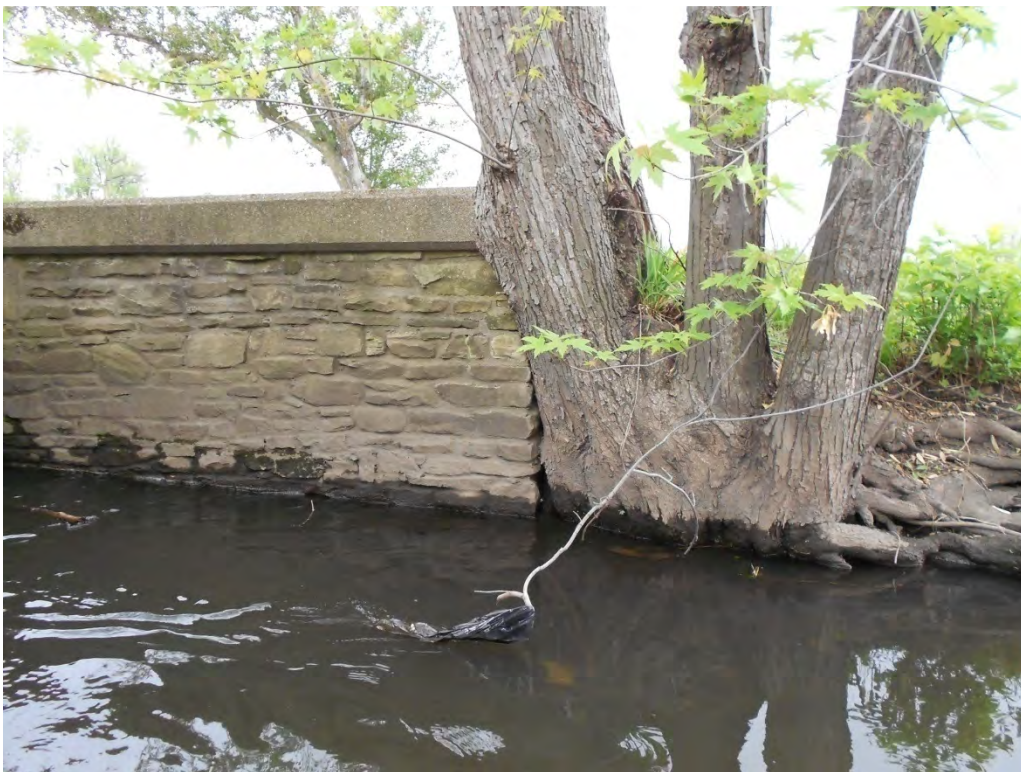
Tree growth at end of southeast wingwall

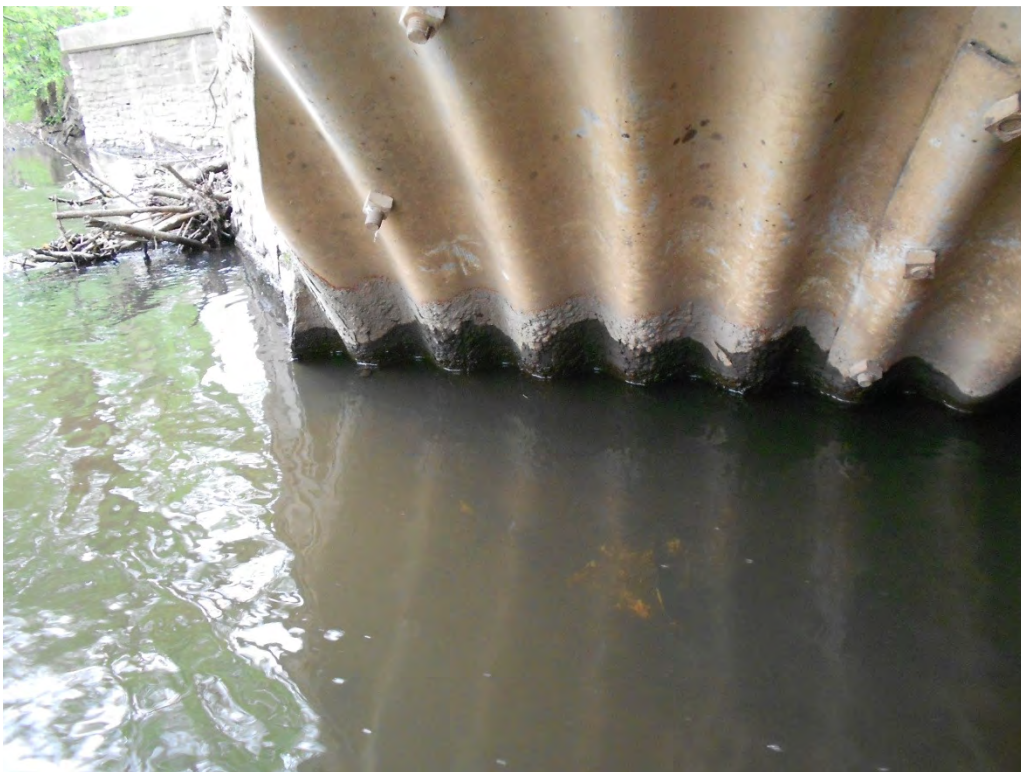
Corrosion and scaling of steel plate along waterline in southeast

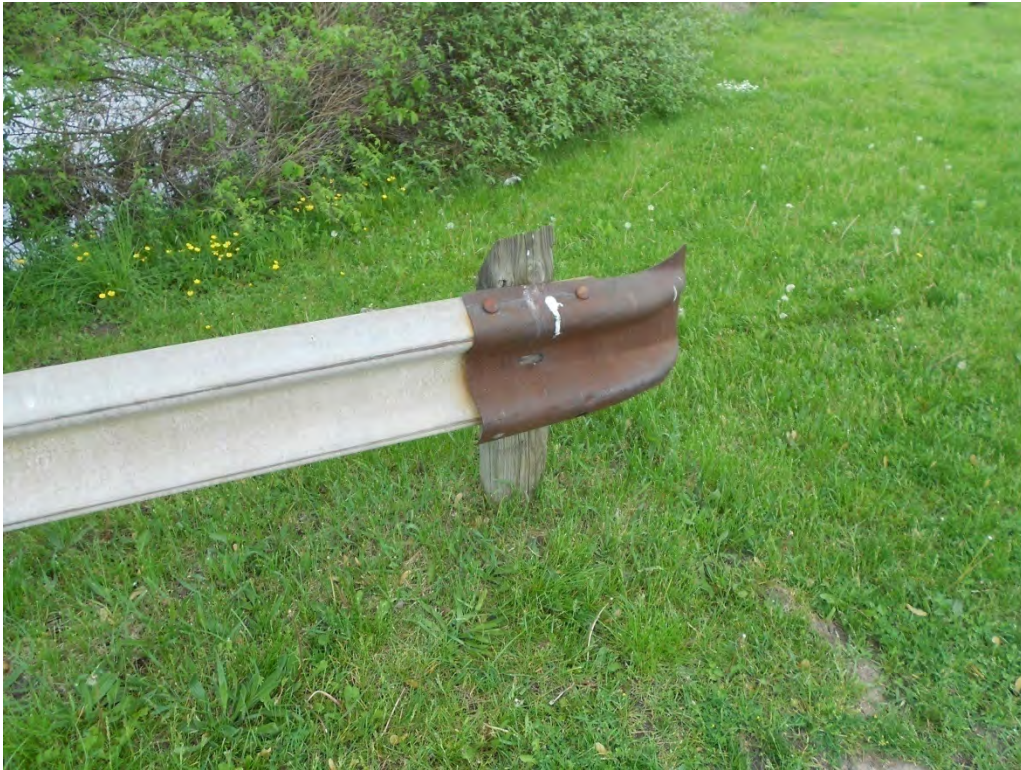
Corrosion on end of northeast approach guardrail

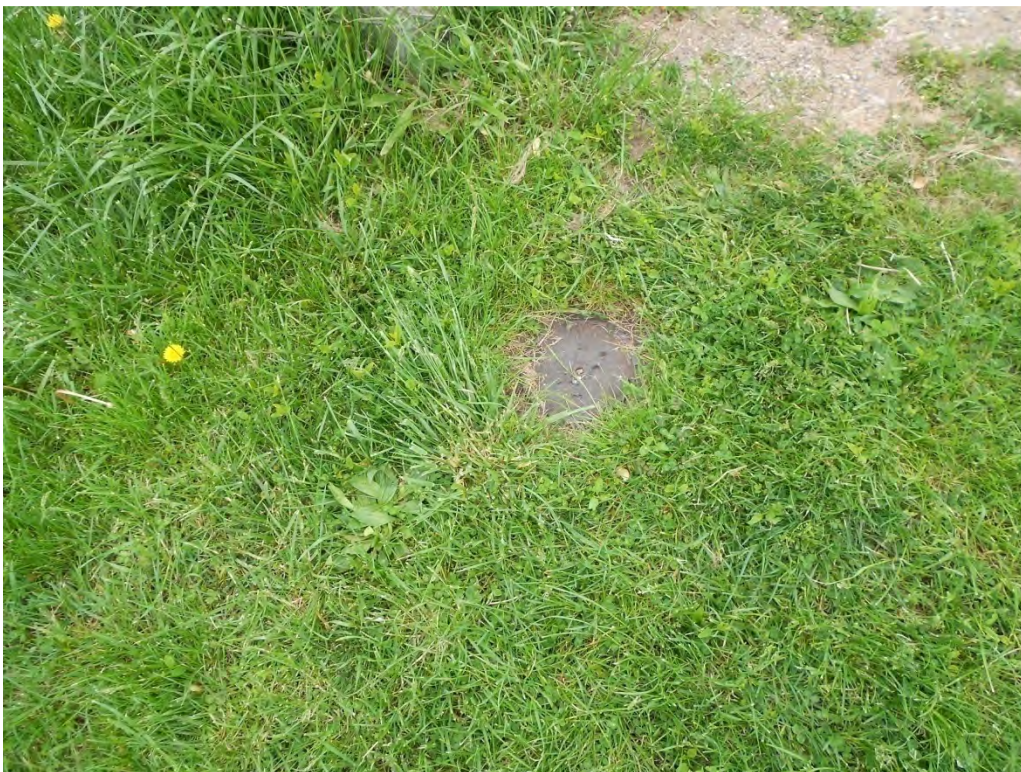
- There is an unidentified steel cover in the northwest and an abandoned conduit on the north headwall.
- Severe erosion was noted around the northwest wingwall with failed concrete rubble placed as riprap. Minor gaps and cracks were noted in the mortar joints.

Unidentified steel cover in northwest

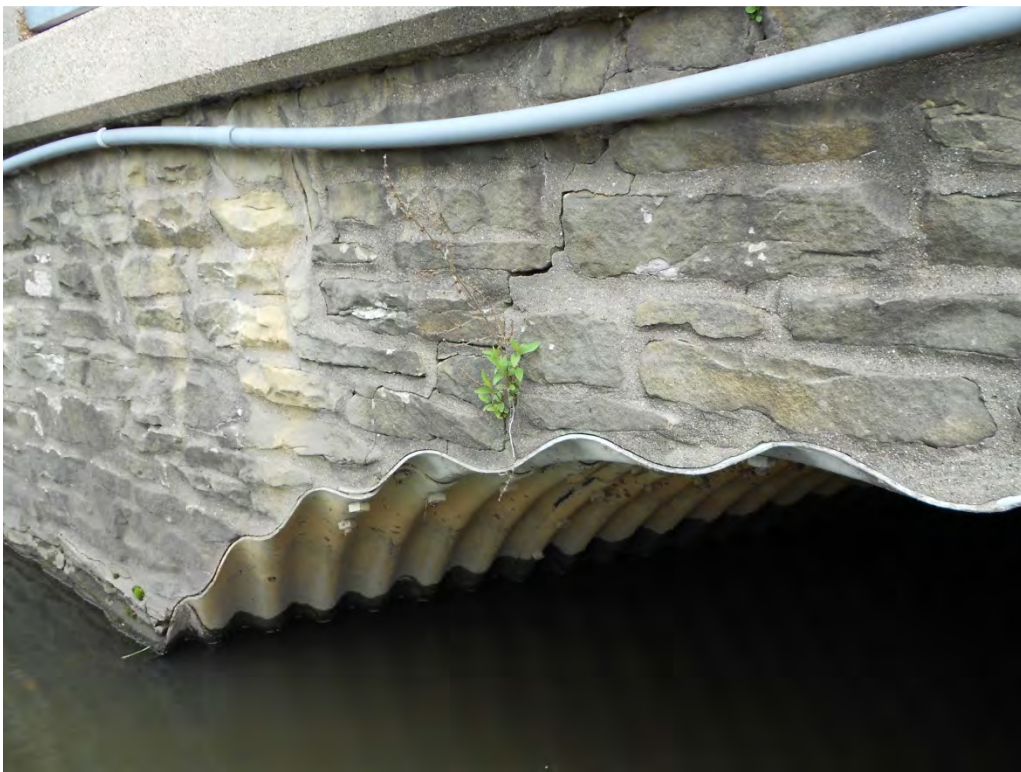
- The north headwall has moderate to severe step cracking in the northwest with vegetation and severe horizontal / step cracking in the northeast up to 1/2" wide.

Step cracking in northwest headwall

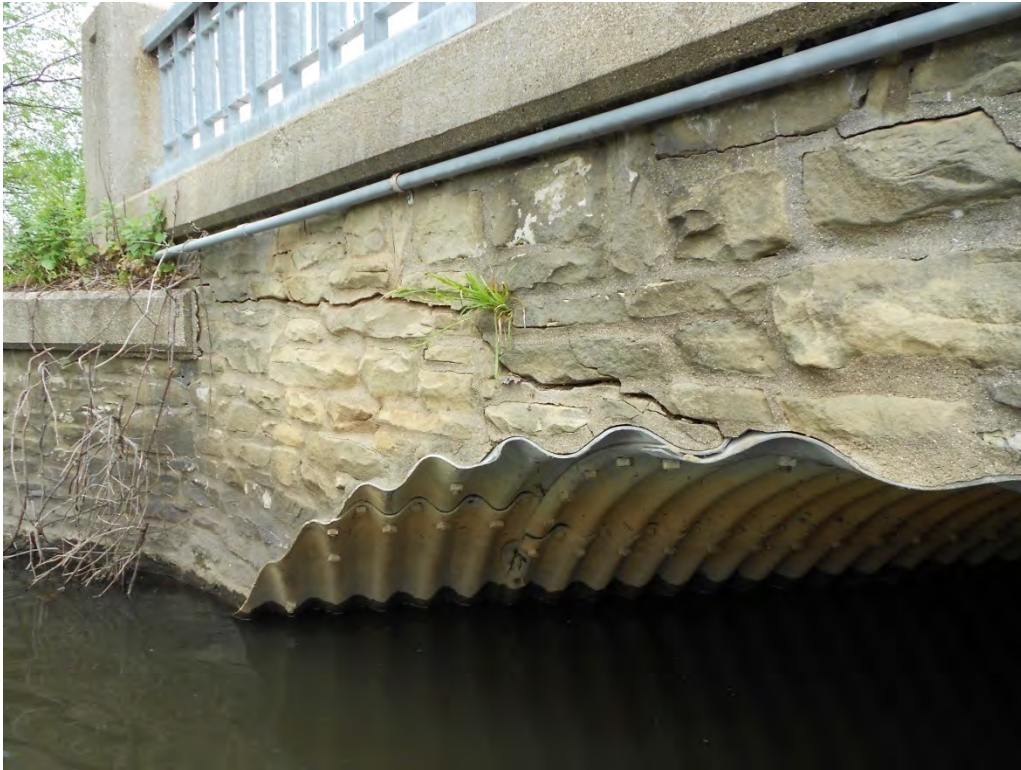
Horizontal and step cracking in northeast headwall

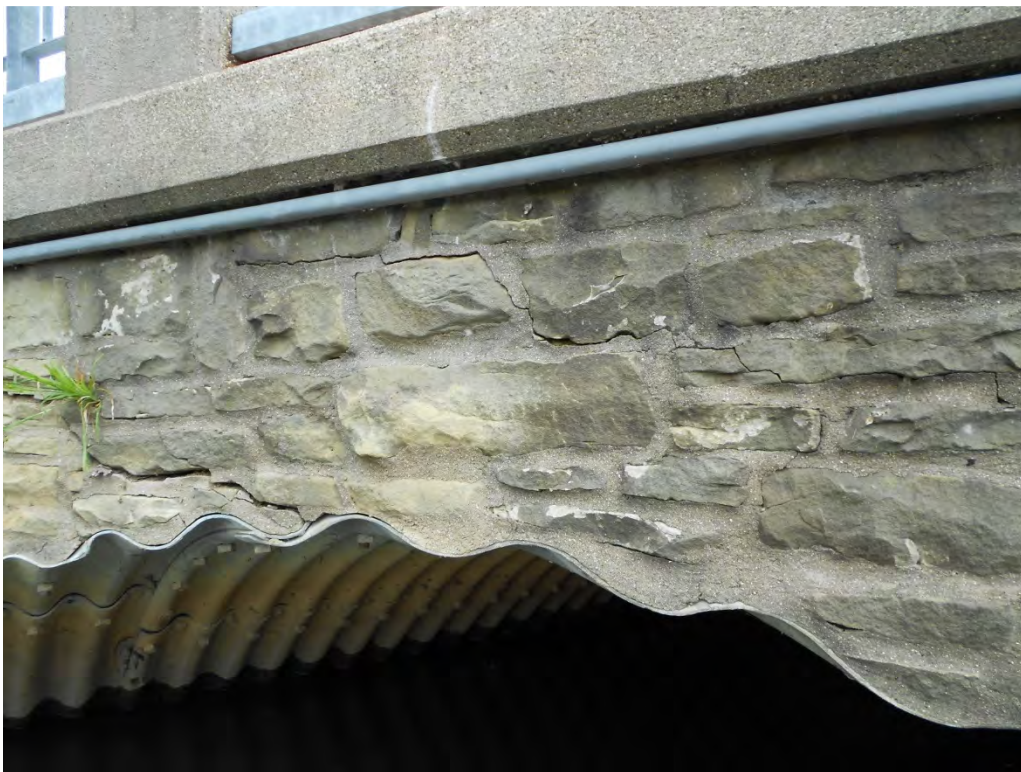
Step cracking in northeast headwall

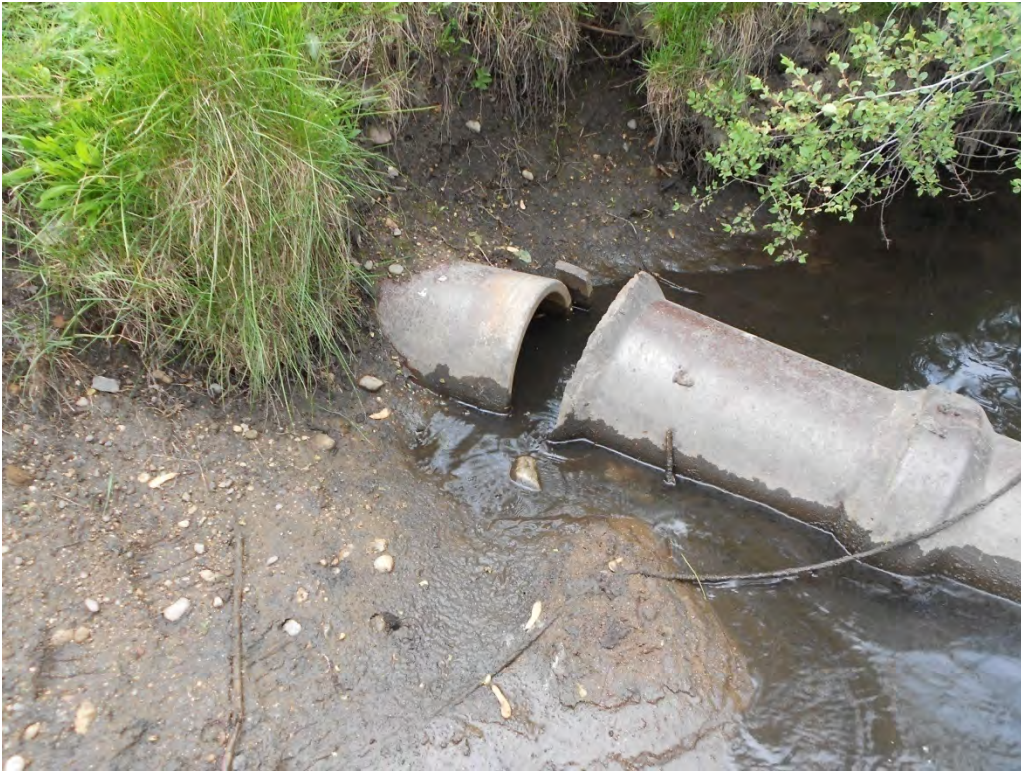
- There are 3 failed sections (~6') in the channel and the 4th exposed approximately 12" from severe bank erosion.

Cracked bell at failed section

- Remove the 3 failed sections. Protect the outlet with an isolation cofferdam to allow for dewatering.

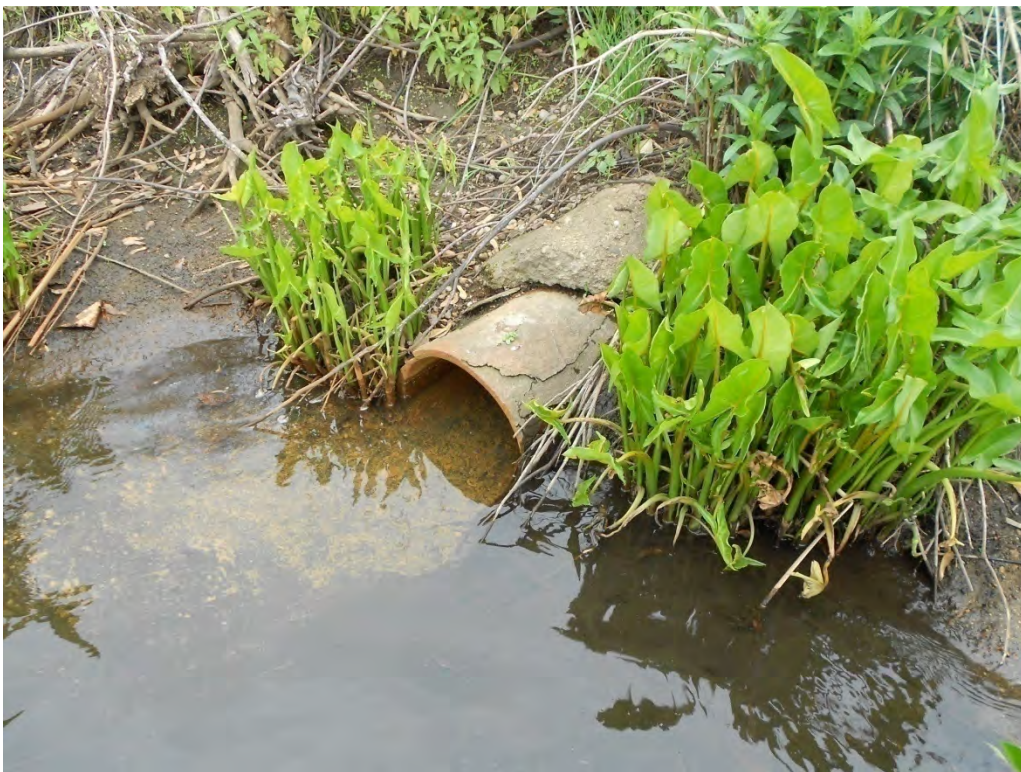
- The end of the pipe is exposed ~12" from bank erosion in the area. It is severely cracked and scaled.
- The concrete collar around the pipe is severely spalled.

Cracking and scaling of end section and spalled concrete collar

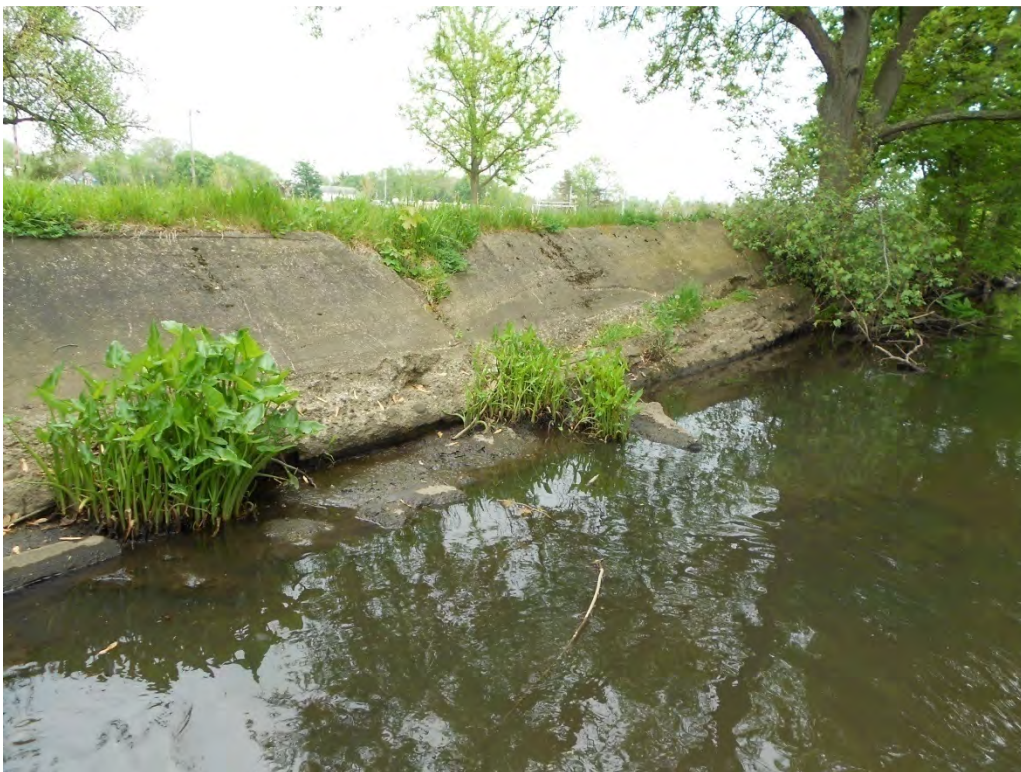
- The concrete is abraded at the waterline with severe cracking and settlement of the slabs.
- There is significant vegetation growth between the slabs and through cracks.
- There is a significant amount of failed rubble in the channel along the toe of the bank.

Cracking and vegetation growth through the structure

- Remove and replace the slabs as required to facilitate cofferdam installation and sediment removal.

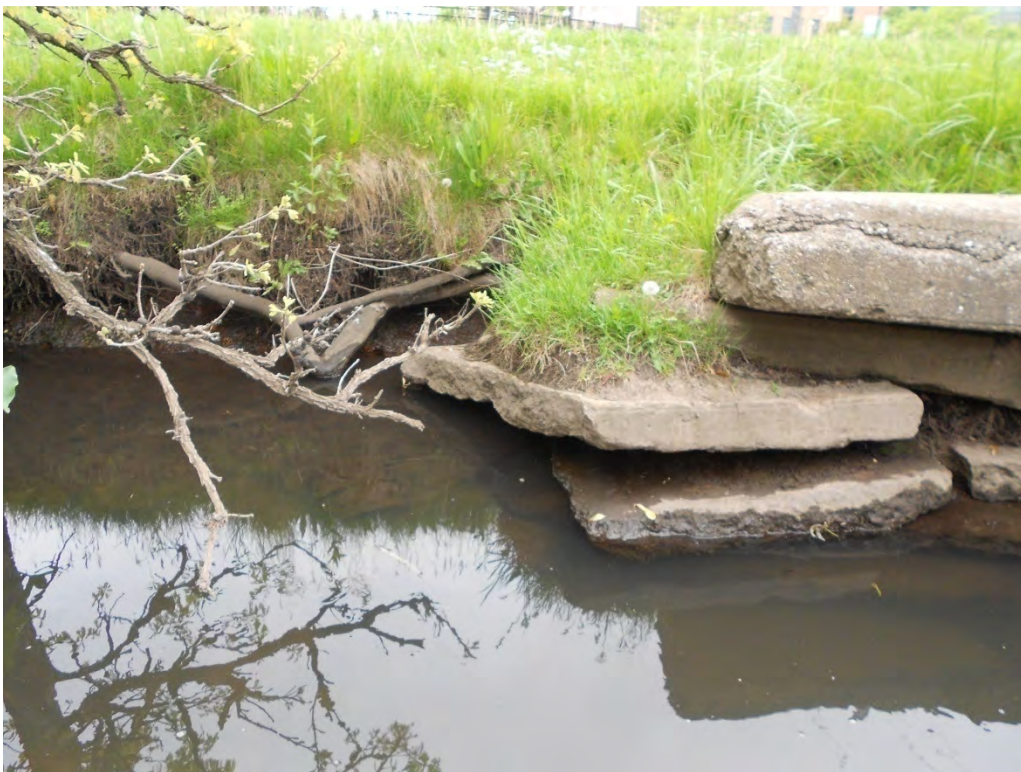
- The 12" concrete storm sewer outlet is severely abraded/spalled exposing the steel reinforcement.
- Slabs have severe cracking and settlement, approximately 2" at the southwest concrete wingwall of the Vine Street bridge.
- There is significant vegetation growth through the wall.
- The south end has severe bank erosion with a sink hole behind the wall.

Failing slabs at the south end of the structure

- Remove and replace the slabs as required to facilitate cofferdam installation and sediment removal or extend the cofferdam around the structure with approximately 4' clearance.
- Protect the storm sewer outlet with a cofferdam to allow for dewatering. Because of its proximity, the cofferdam will likely be part of the cofferdam for the Vine Street bridge.

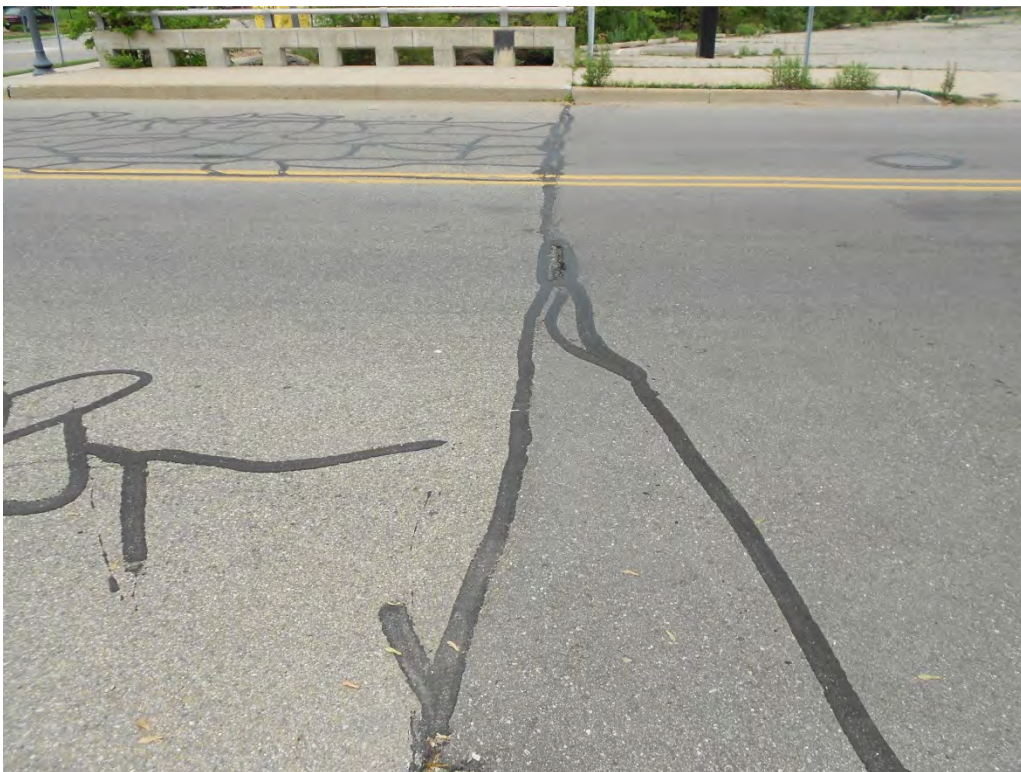
- The asphalt surface has block cracking which is mostly sealed in north lane and south wheelpath. Severe transverse cracking, partly sealed, was noted along the reference lines.

Partially sealed cracking in the asphalt surface
